June 10, 2015

Reference: Rainbow Lakes West Third Addition – Lake Assessment

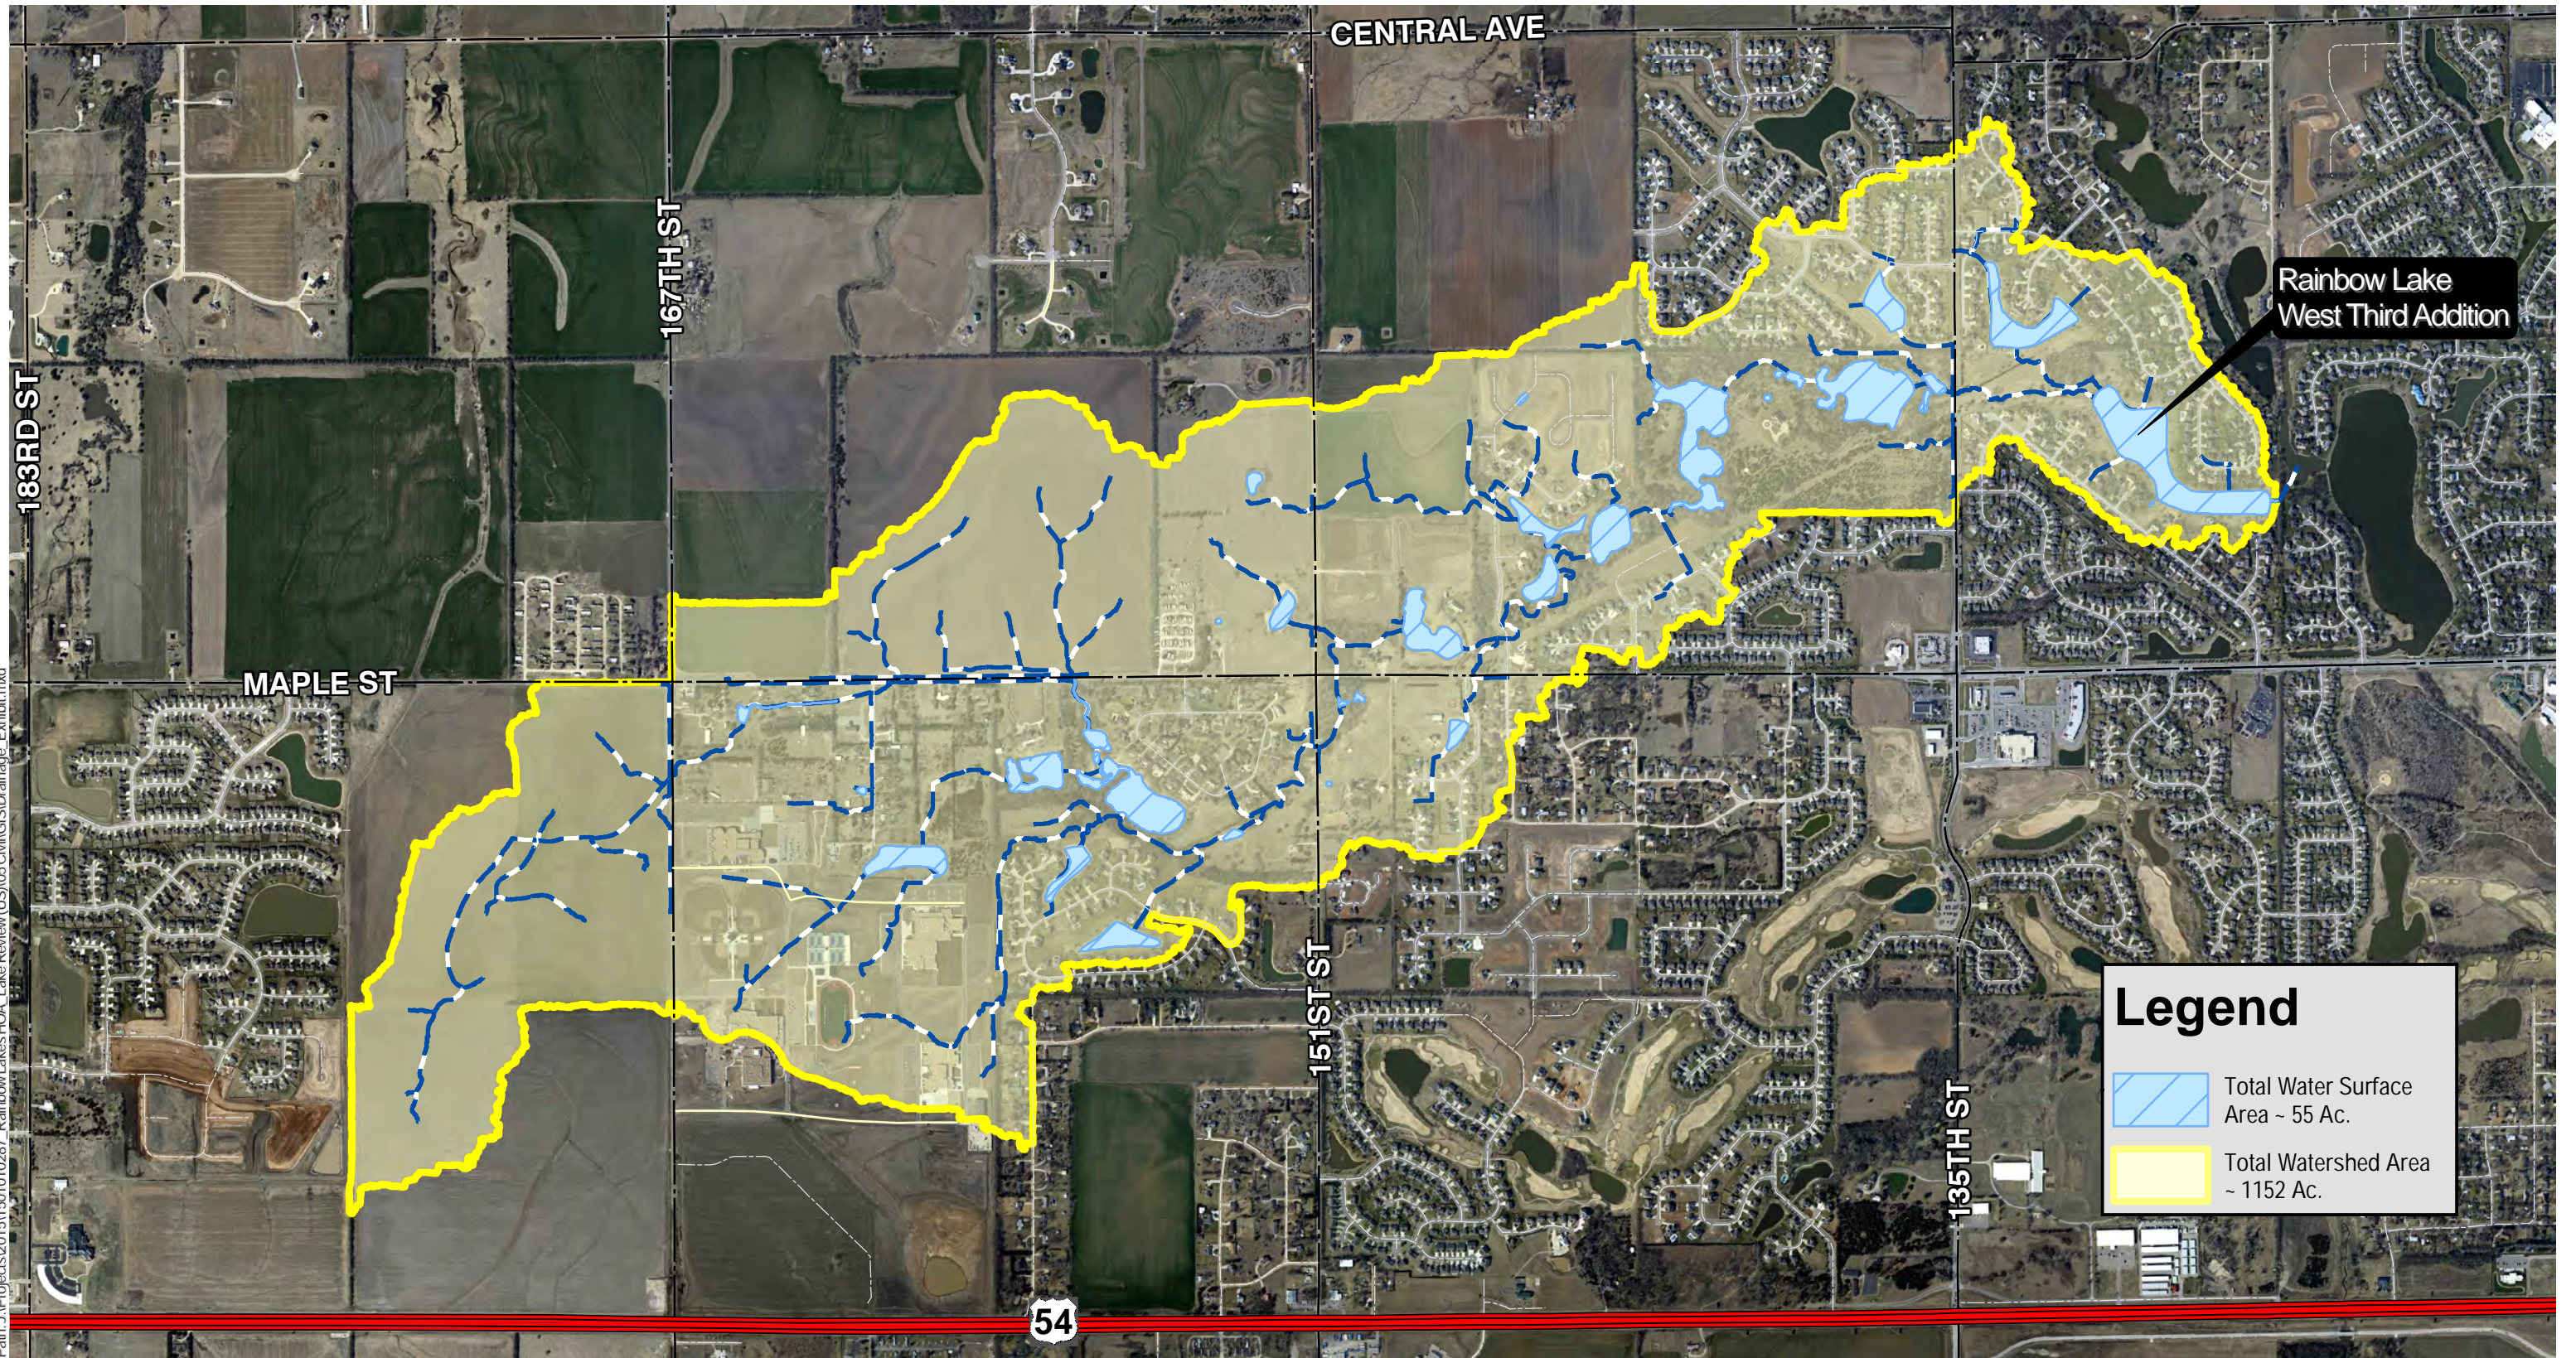
DRAINAGE BASIN EXHIBIT

While investigating the 1152 acre basin, MKEC discovered that approximately 55 acres of water surface exist. Typically 30 acres of watershed is required for every 1 acre of water surface to maintain a healthy pond. This basin has approximately 1 acre of pond surface area per 21 acres of watershed. The ponds in this watershed exceed the typical ratio; therefore the ponds compete with each other for the limited volume of runoff. During times of drought the water surface elevations of all of the ponds in the watershed will drop due to evaporation. Upstream ponds will fill up prior to downstream ponds when rains return. Until upstream ponds reach normal water surface elevation, water is not released to downstream ponds. Small storms within the basin may not be able to supply surface water to the lake.
